## ORBITER PROCESSING FACILITY SERVICE PLATFORM FAILURE AND REDESIGN

Jesse L. Harris\*

THE MISHAP

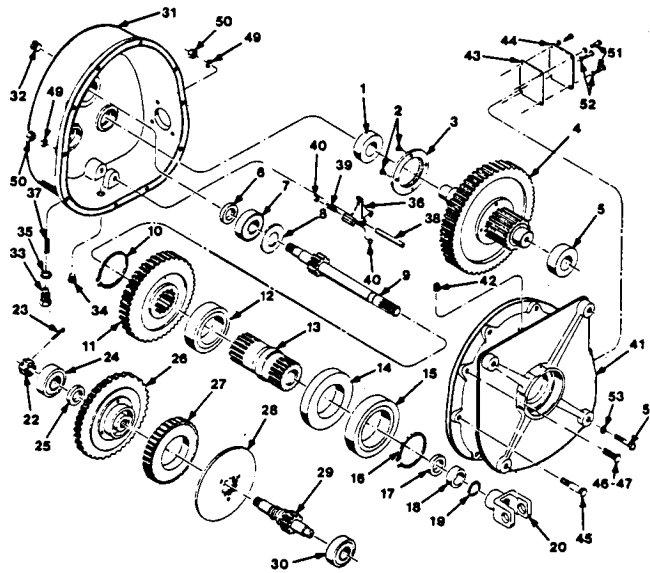
Figure 5

A study of the hoist revealed that the load control brake ratchet pawl stop, item 34 in Figure 5, a hex head screw, was located adjacent to the gearbox oil drain plug, item 33 in Figure 5. The two could be easily confused and inadvertent removal of the brake ratchet pawl stop would cause the brake to become nonfunctional. Labels were attached to the drain plug and the ratchet pawl stop bolt was sealed to the gearbox case.

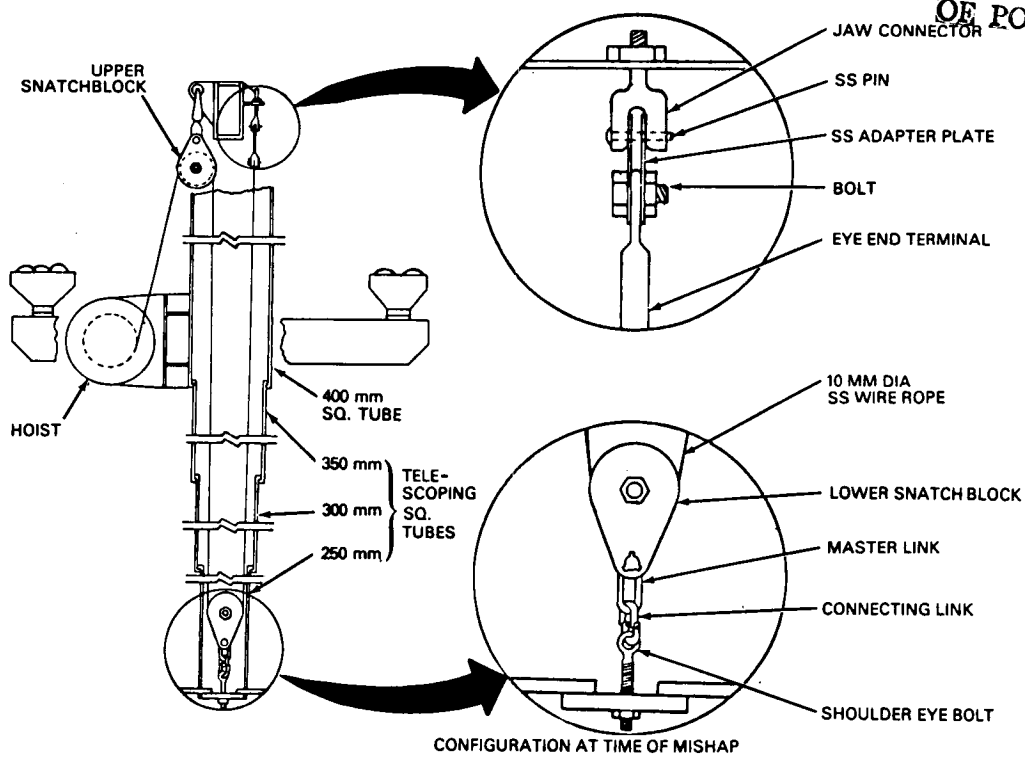
Figure 7

The direct cause of the mishap was a failure of a hoist system master link, Figure 7, allowing the bucket to fall, Figure 8. The master link attached the lower snatchblock to the Bucket and was probably broken by locking up the Bucket's vertical hoisting system. The locking up resulted from the Bucket being raised until the telescoping tubes had reached their upper travel limit and were physically prevented from further motion. The hoist continued to drive applying an increasingly large force to the lower snatchblock and master link assembly causing the master link to break. An electrical limit switch designed to shut off power to the hoist prior to the tubes reaching their upper travel limit had been misadjusted and did not engage, Figure 9. The hoist system was designed to have redundant wire ropes, lower snatchblocks and master links loaded in parallel.

10. The master link failed at less than its rated capacity.

The failure of the master link at less than its specified breaking strength is an example of a manufacturer's desire to get the most from his product. In this case the rated breaking strength was based on unpublished test conditions. These conditions were not only omitted from his catalog and engineering design manuals, but were not even common knowledge of his engineers. When critical systems are involved it pays to test the components to determine their limitations.

The hoisting system components, Figure 11 & 13, were repositioned to allow access for inspection of the wire ropes and wire rope pulleys. The lower snatchblock and master link assembly were eliminated.

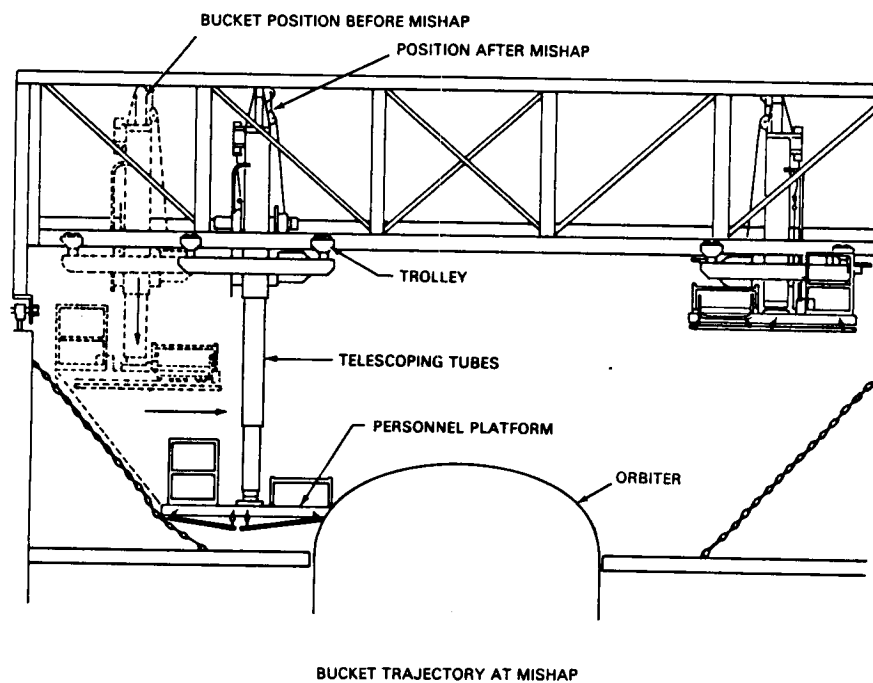
Figure 8

An earlier failure of one of the master links had occurred at which time the Bucket was removed from service and "Do Not Operate" tags were attached to the Bucket control stations. The mishap occurred upon failure of the second master link after the Bucket was tagged out. The primary cause of the mishap was attributed to operator error due to unauthorized use of the tagged out Bucket.

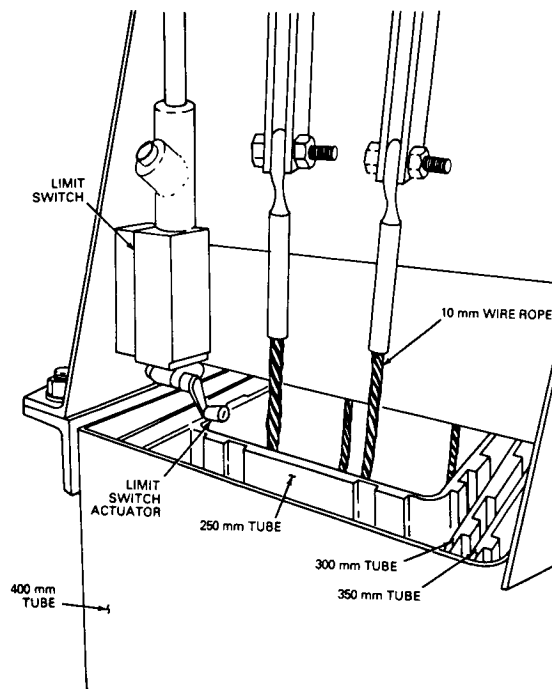
Figure 9

25 mm below the limit. The switches were also reoriented to eliminate the misalignment problem which contributed to the mishap. The change in alignment can be seen in Figures 9 & 13.

LIMIT SWITCH CONFIGURATION AT TIME OF MISHAP

1. Redundant limit switches were installed at the upper end of the telescoping tubes. The switches were placed in series with the first switch located 45 mm below the physical upper travel limit and the second located

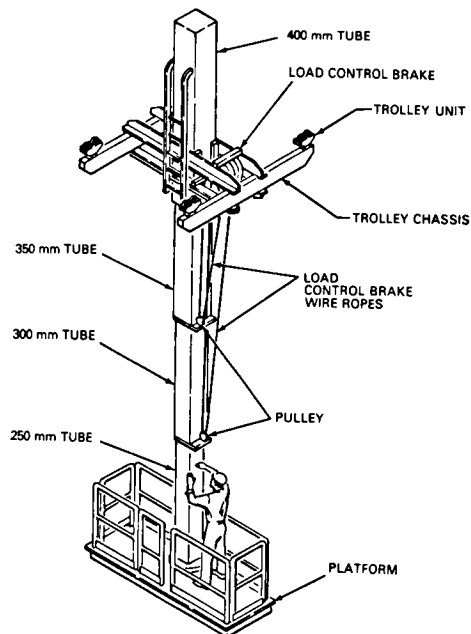
Figure 10

Inspection of the telescoping tube travel stops revealed damage caused by the tubes binding then working loose, freefalling and impacting the stops. Methods to individually drive each tube with jackscrews or wire ropes were rejected as being difficult to control and requiring too much space. It was decided that a method to control the fall of the tubes would be more practicable. The tubes if they should hang up would be allowed to fall but the descent velocity of the fall would be limited.

is actually a personnel escape device used by construction workers to jump off buildings in emergency situations. The device has an internal centrifugal brake that will limit angular velocity similar to the rotary dial in a dial type telephone forced in the counterclockwise direction. The load control brake is attached to the trolley chassis with an 8 mm wire rope routed down through a pulley on the telescoping tube, and back up to terminate at the trolley chassis, Figure 10.

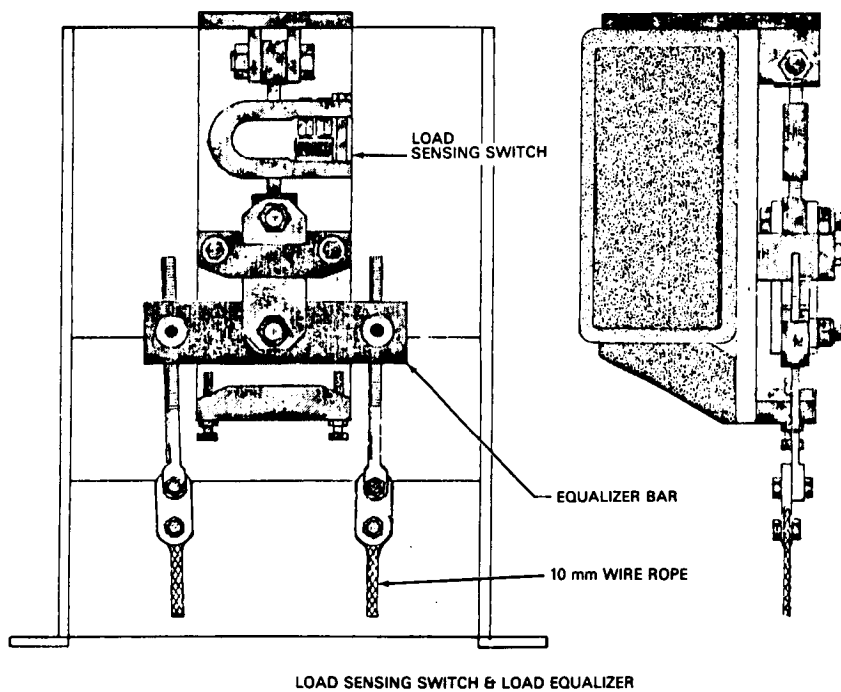
Figure 12

A failure test of the wire rope pulleys, Figure 13, and load limiting switch assembly, Figure 12, was conducted to verify that the manufacturers rated breaking strength was valid for the configuration in which they were being used. The test results confirmed that the weak link in the system was not the wire rope, which was analyzed as the weakest element, but the load limiting switch. The switch failed at 95% of its rated breaking strength. The test did confirm that adequate safety factors were provided for the system.

A load sensing device, Figures 11 & 12, was installed that would sense high or low hoist loads and shut off power to the system. A load equalizing bar was also installed to maintain equal loading of the 10 mm wire ropes.

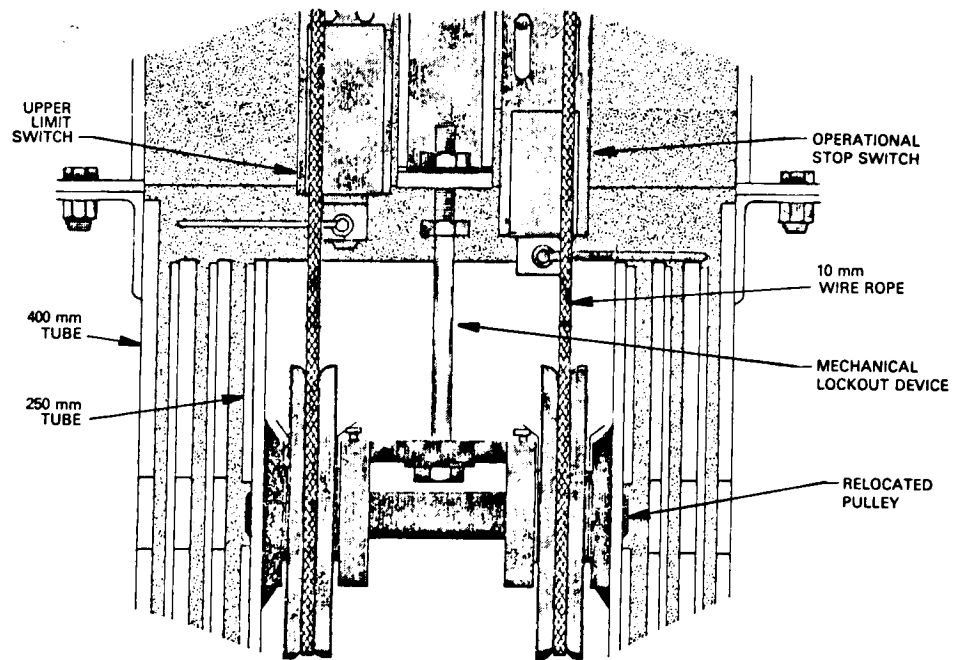
Figure 13

LOWER PULLERS, REDUNDANT LIMIT SWITCHES & MECHANICAL LOCK

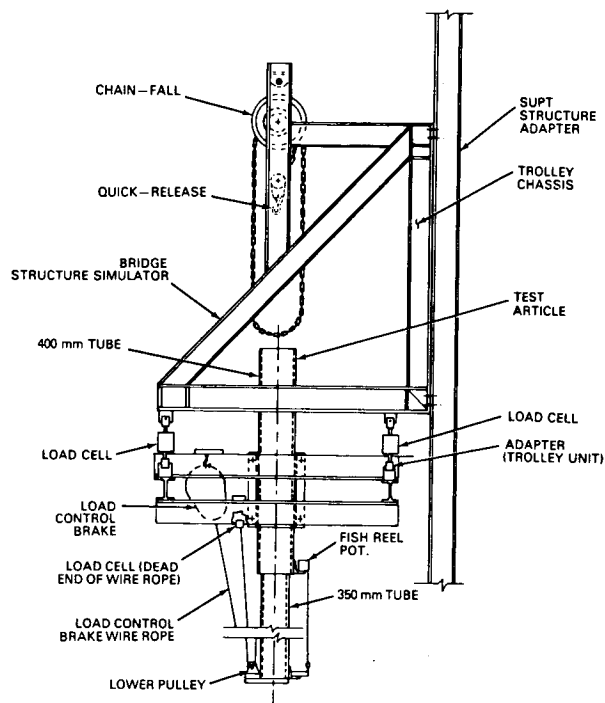
Figure 14

LOAD CONTROL BRAKE TEST RIG

built to simulate the 350 mm telescoping tube and trolley chassis. Load cells were installed at the four corners of the trolley chassis, where the wheeled trolley units are located, to measure trolley loads and at the load brake wire rope termination to measure load brake loads. A linear transducer, "fish reel pot" was installed at the bottom of the telescoping tube to measure displacement and velocity. The telescoping tube was allowed to freefall with the load control brake connected and the loads at the trolley measured during impact of the tube travel stop. All load control brakes are qualification tested in this manner prior to installation on an OPF Bucket.
